**Report upon the existing
window installations
at**

**D'Eynsford Estate
Camberwell, London SE5**

London Borough of Southwark

B7719
June 2015

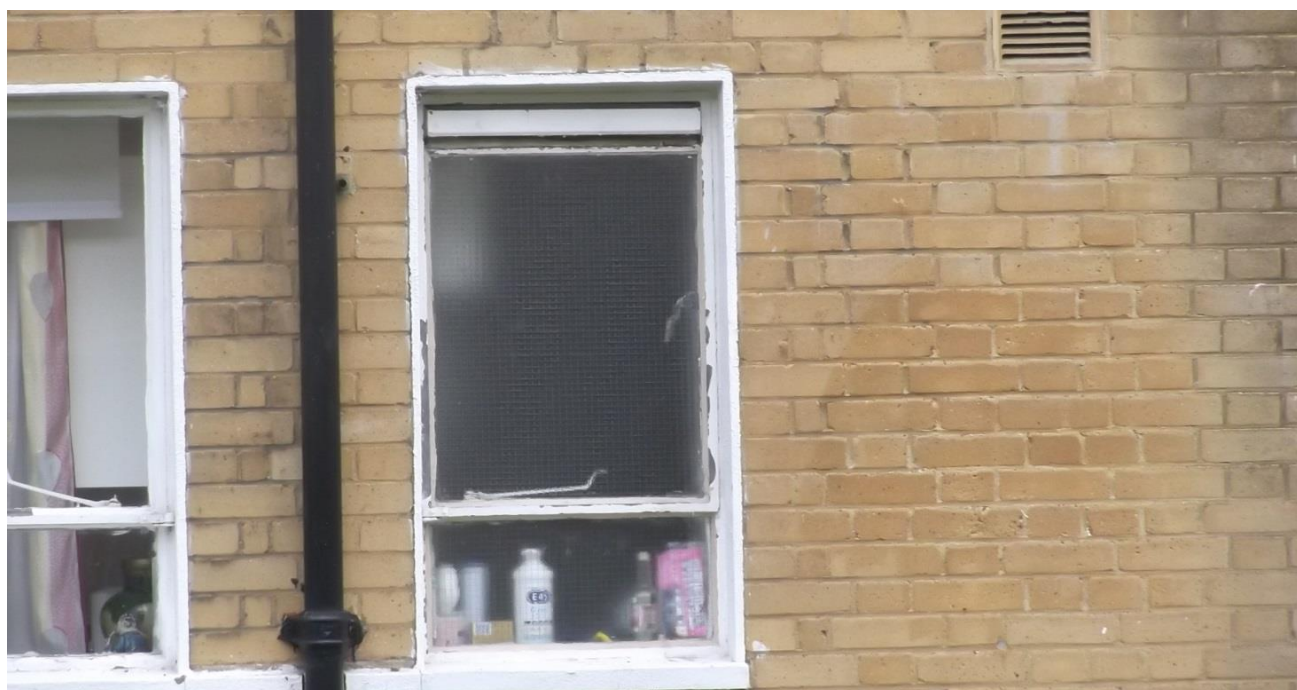
The windows suffer from lack of regular maintenance and as a result, the paint is flaking back exposing galvanised steel below.

The majority are difficult to open and do not close fully.

We recommend that consideration is given to replacing all the windows and private balcony doors with double glazed UPVc incorporating trickle vents in the head of all windows except to bathrooms and kitchens.

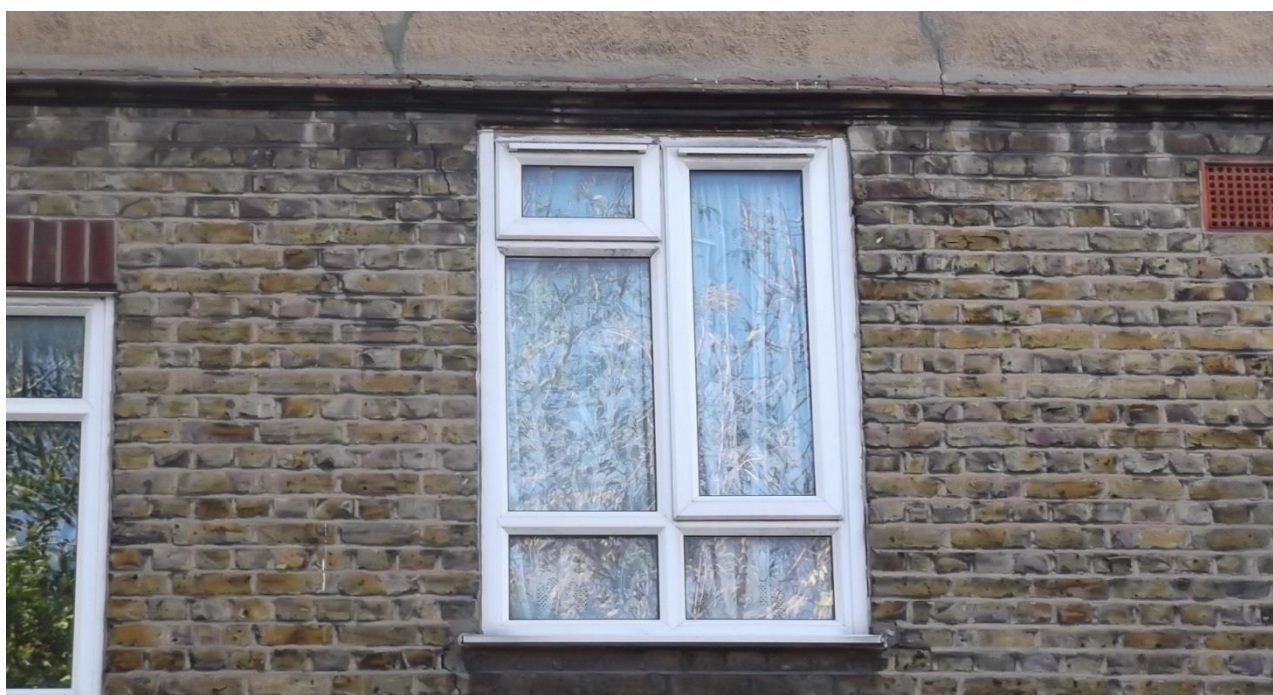
The windows are generally in good condition but we have been unable to ascertain when they were installed but from their condition, we would anticipate within the last ten years.

We recommend that the windows are retained but consideration could be given to changing the rear exit doors to the fire escape to a composite type with UPVC frame and double glazed fanlight over as the existing arrangement is unsightly and offers little security.

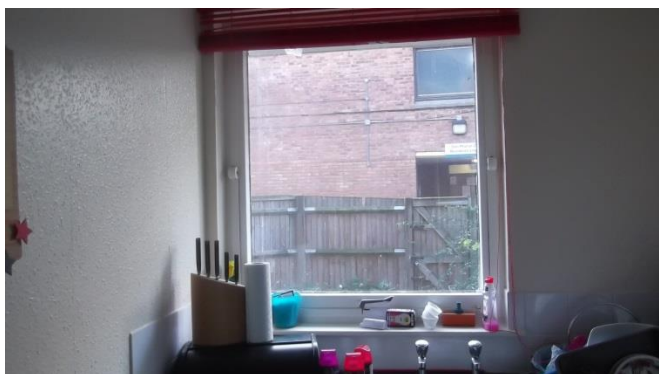
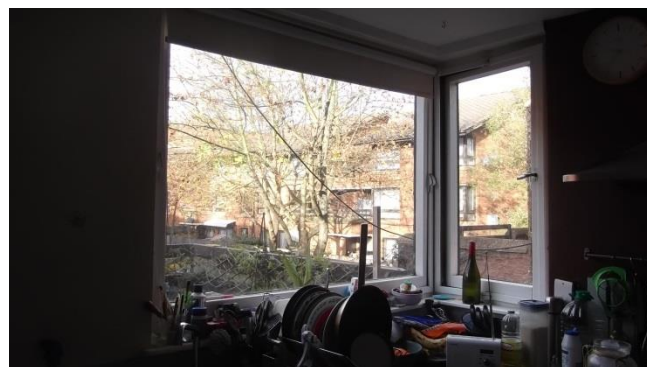
The centre pivot windows are difficult to open especially where they are positioned above the kitchen sink.

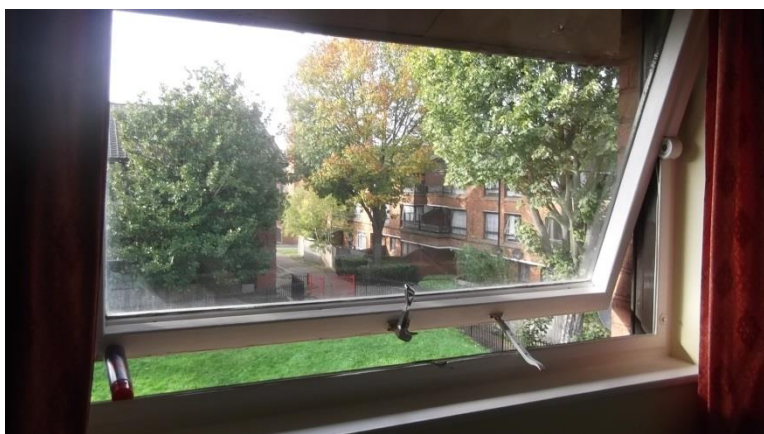
The centre pivot windows which have secondary glazing are especially difficult to open and due to wear of the friction hinges, are not able to be controlled. In one dwelling, the resident had propped open the window with a plastic container and fitted a casement stay but there was no locking pin. (See photo below).

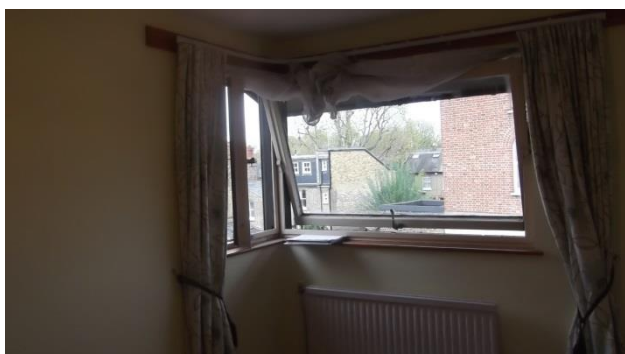
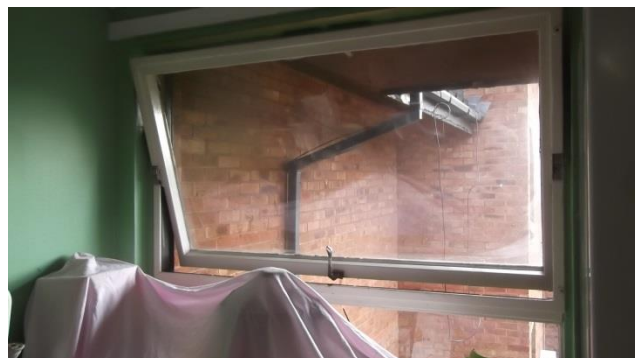
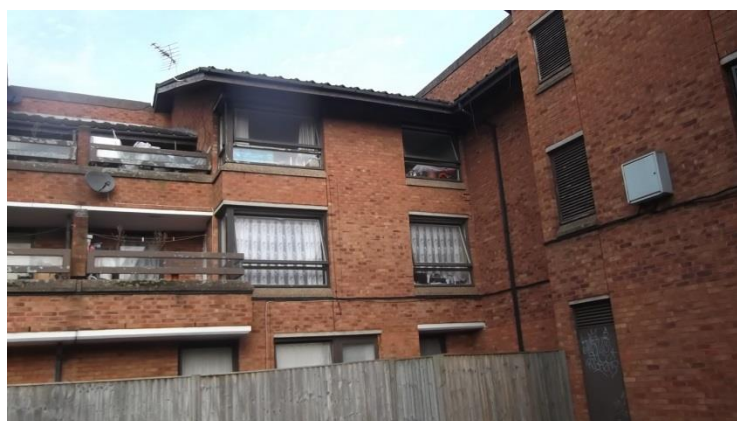
Some centre pivot windows are especially large making partial opening difficult due to wear in the friction hinges.

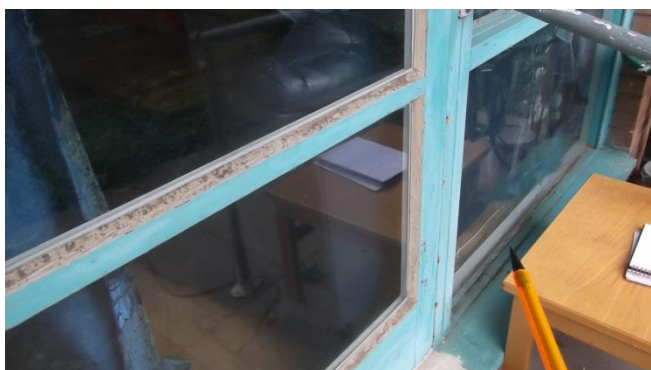
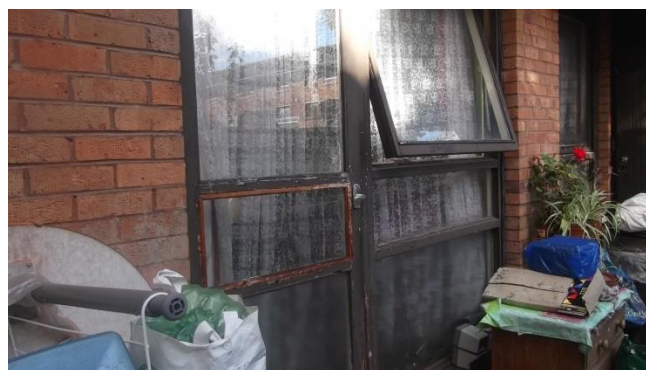
Some glazing has been replaced and secured either with unpainted putty or timber beading.

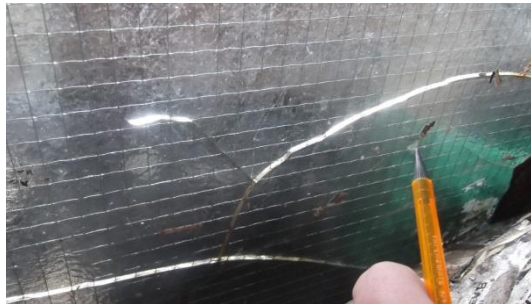
Some glazing is broken/cracked.

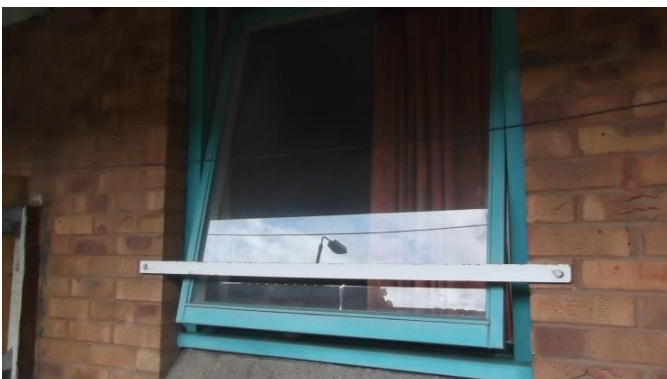
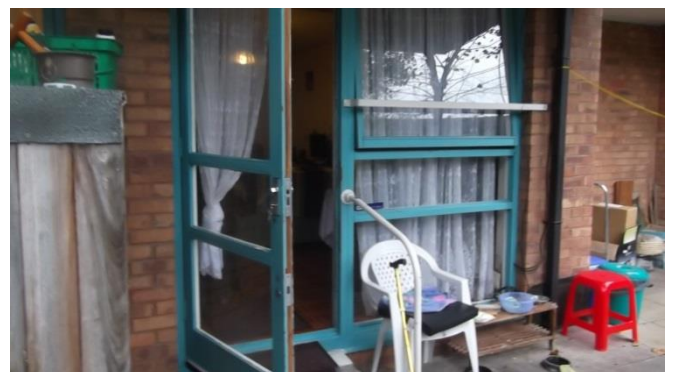
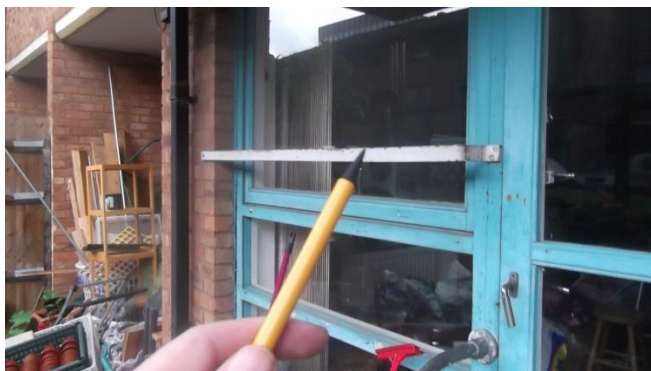
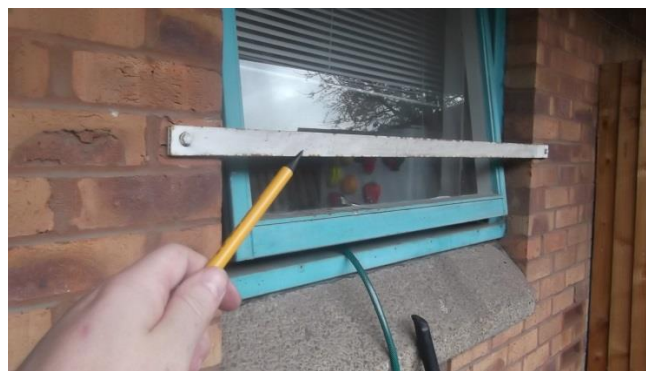
In an attempt to restrict the amount the windows can open and make them safer, some residents have fitted metal restraining straps bolted to the brickwork

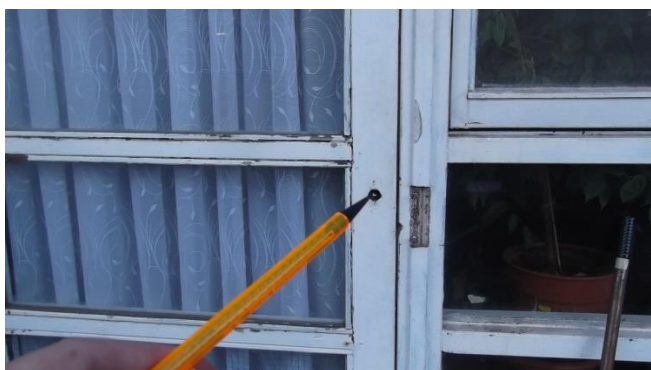
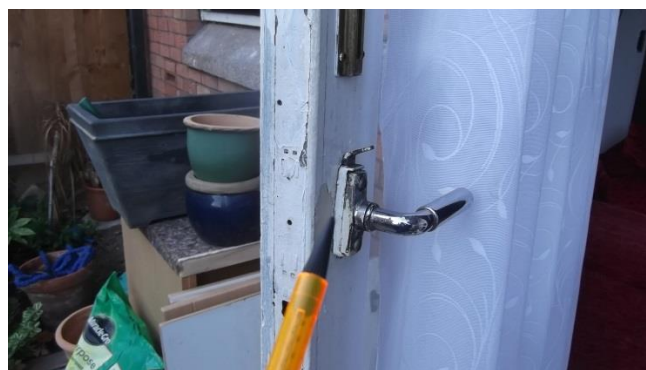
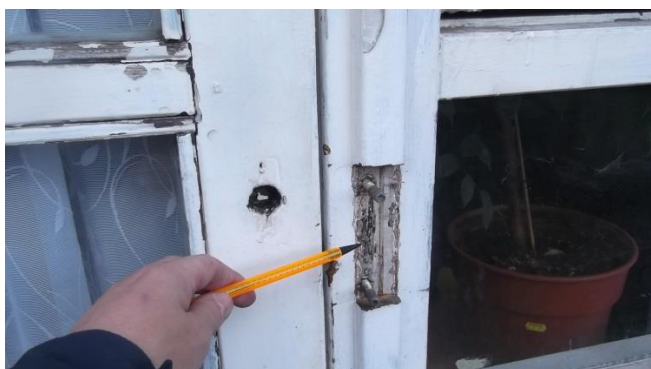
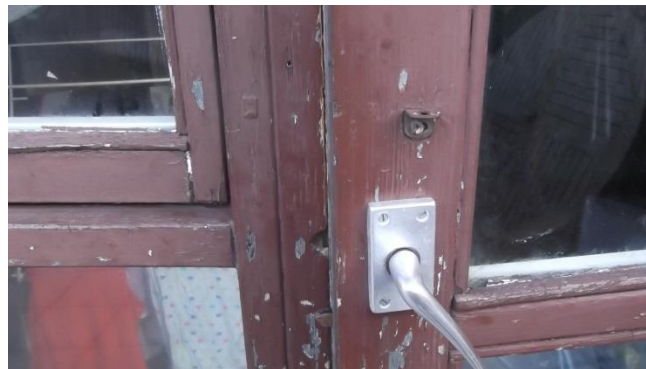
We found that a number of the doors leading to the balcony had handles missing/broken/replaced with non matching.

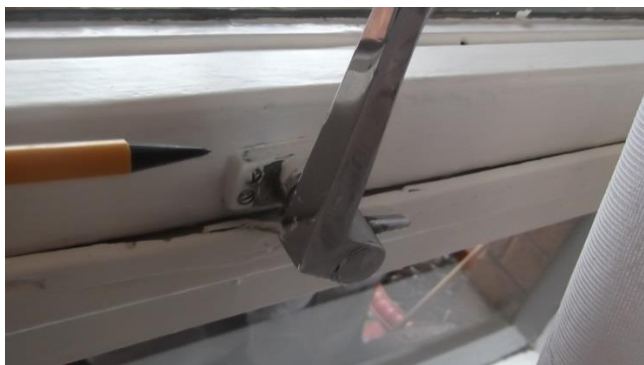
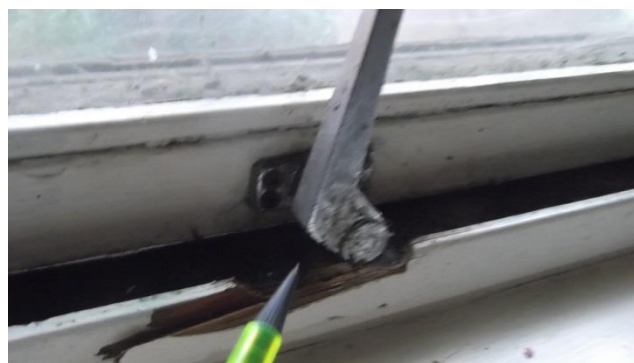
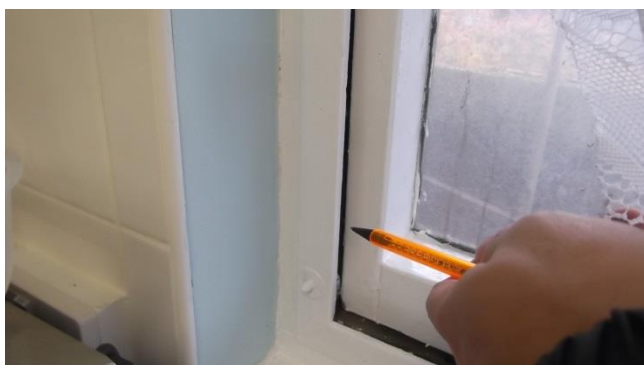
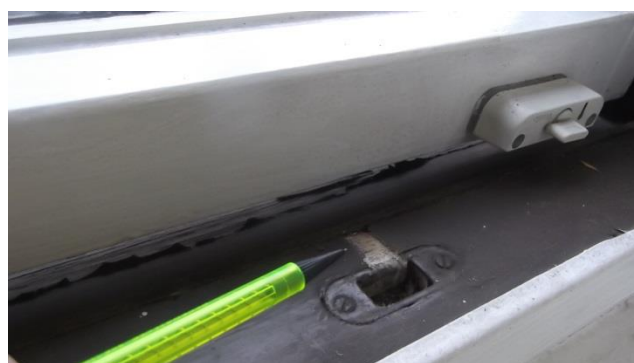
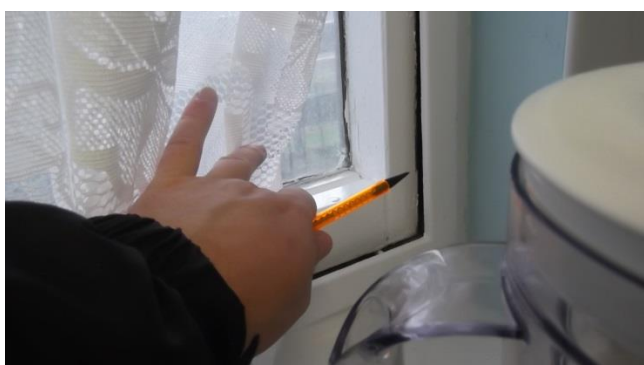
A number of windows did not close fully and/or had misaligned/broken handles.

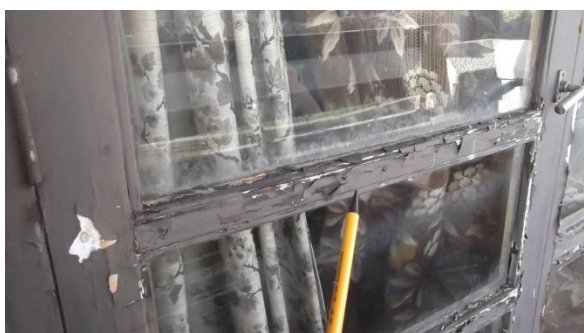
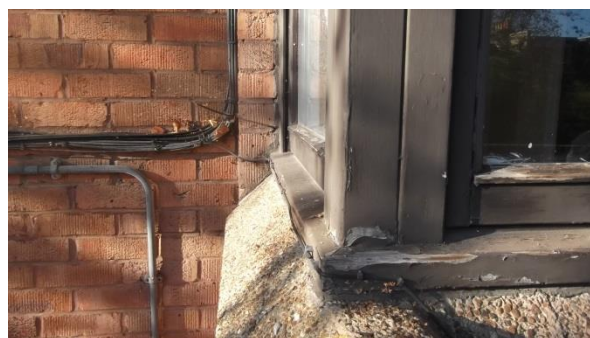
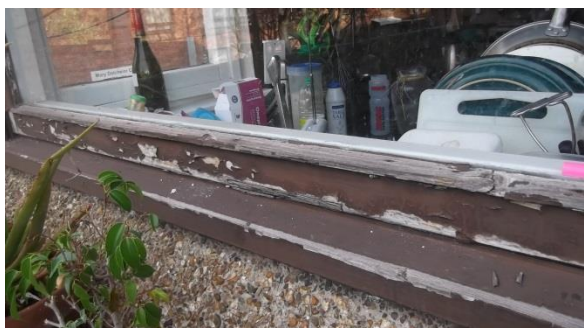
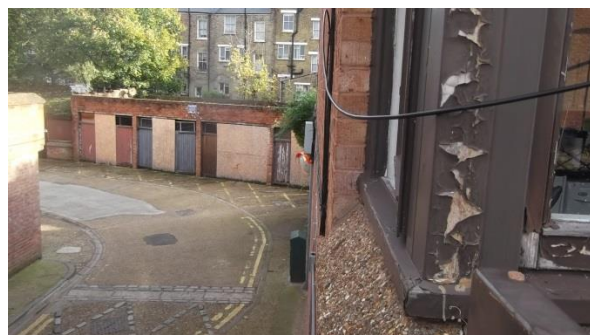
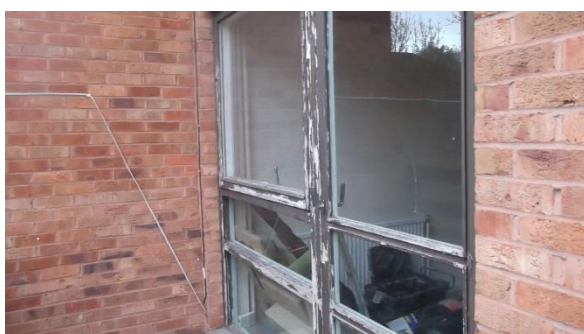
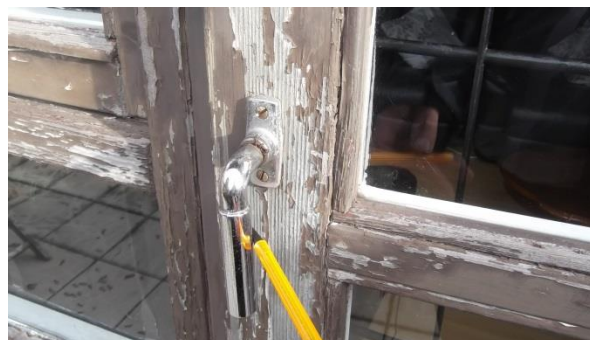
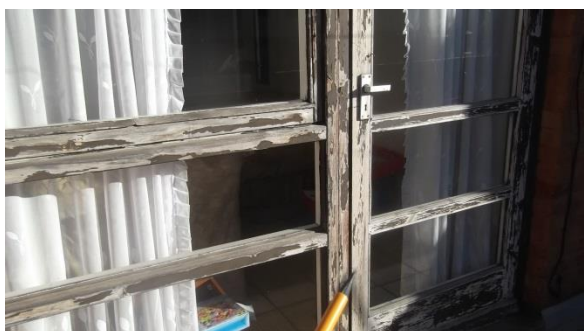
The external surfaces vary in condition dependent upon their situation and exposure. However, it appears that they have not been subject to a cyclical redecoration programme and have generally deteriorated. In some instances, the paintwork has peeled right back to bare timber.

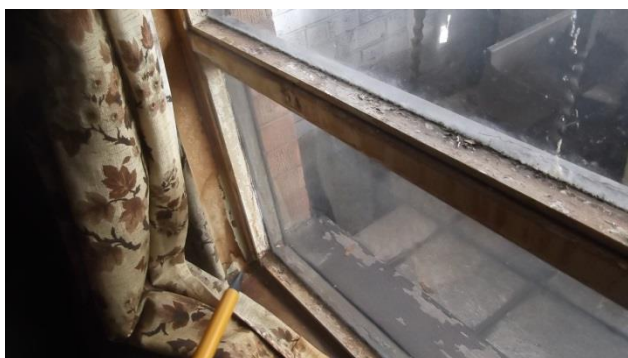
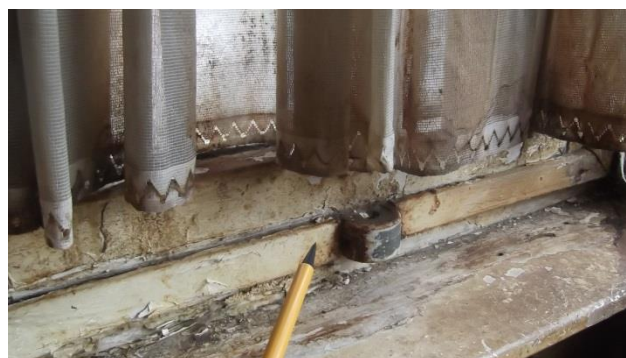
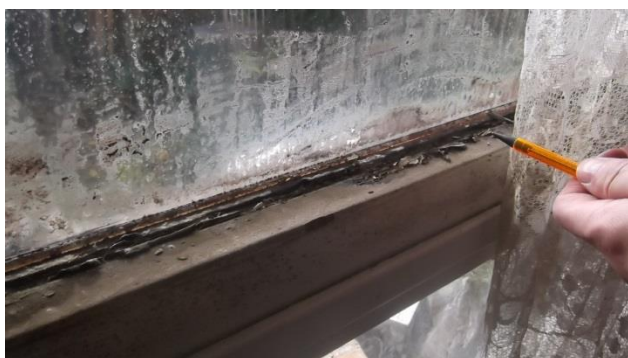
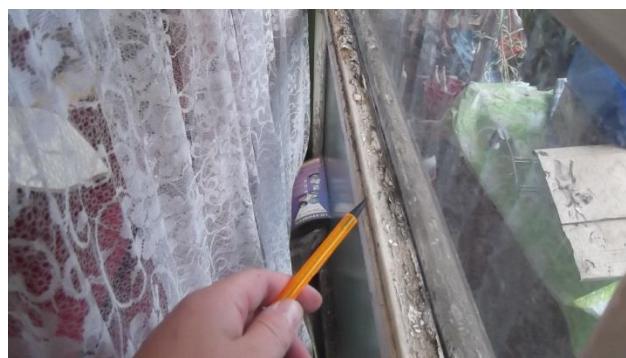
Due to the size of the glass areas in the windows, they are prone to condensation in the winter months which runs down the glass subsequently causing deterioration of the paint finish to the window frames, window board and reveals if not regularly wiped down.

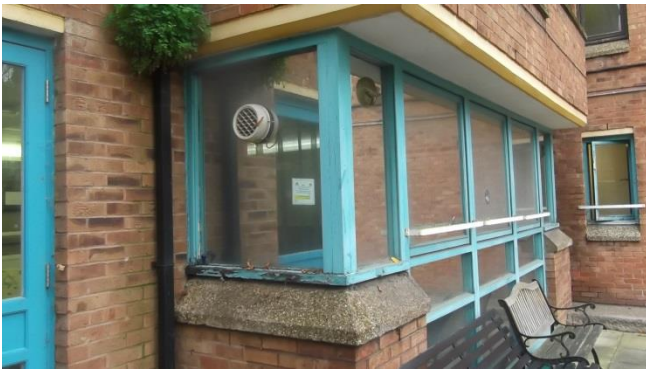
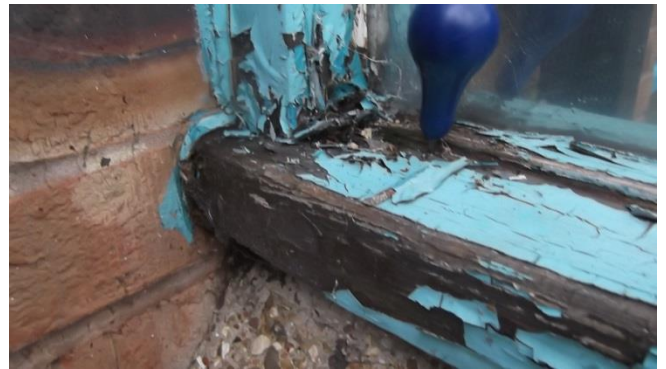
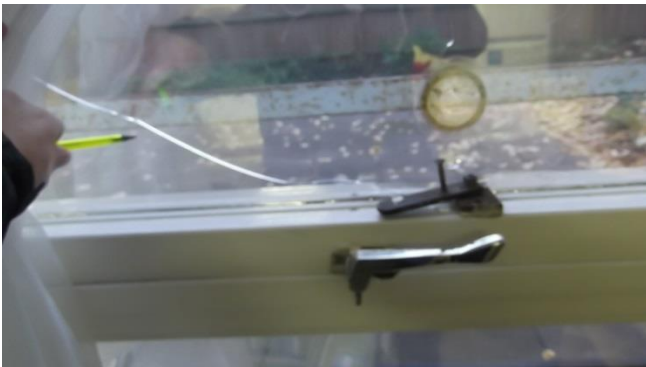
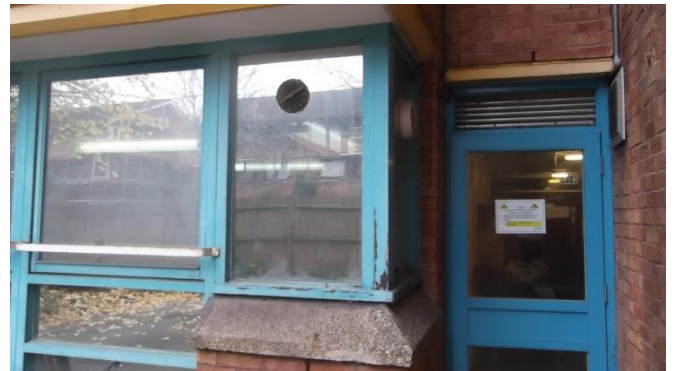
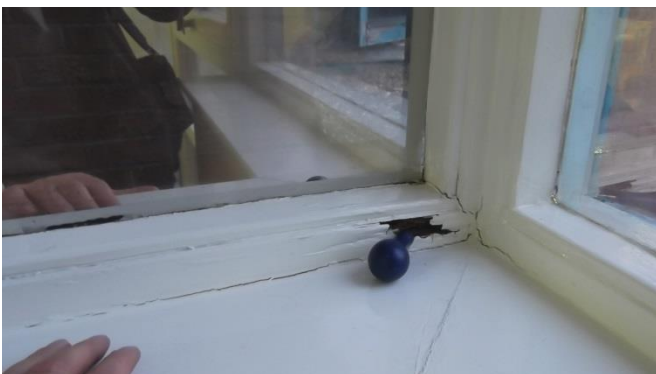
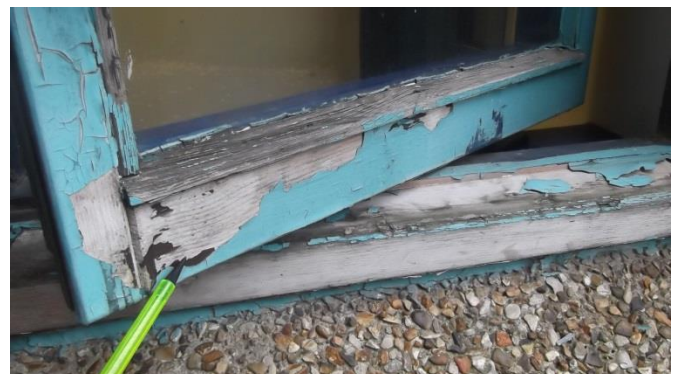
Sheltered Unit Meeting Room

The timber window units are affected by decay, especially the cills. There is also flaking paintwork and broken glazing.

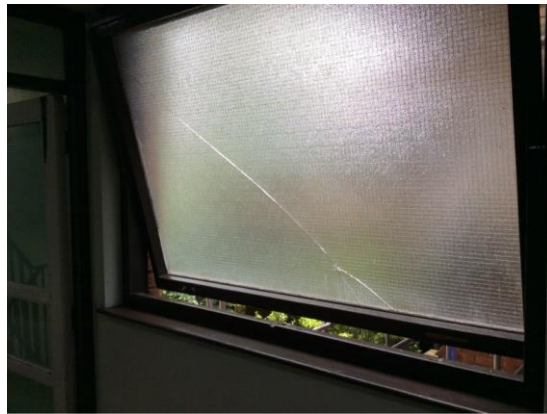
The windows in the communal areas are single glazed pivot. We found a number of defects ranging from cracked panes of glass, windows fixed shut, faulty opening mechanism which did not allow them to open fully, missing handles etc.

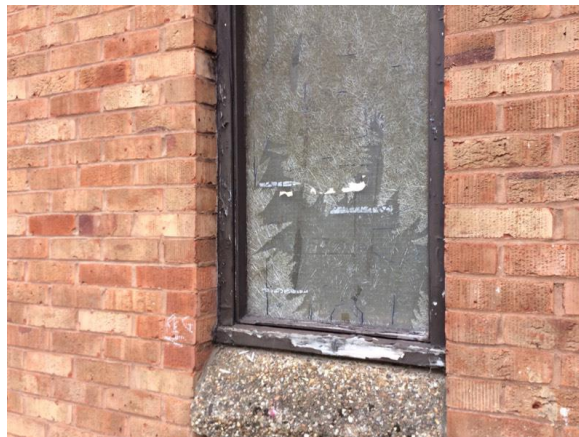
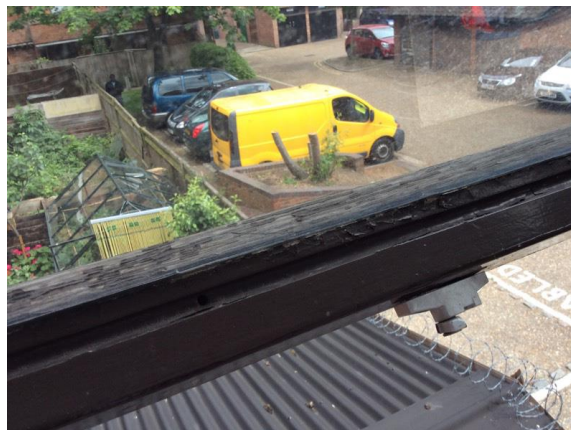
The external paint finishes were generally flaking off exposing bare timber in places.
