**Report upon the existing
window installations
at**

**D'Eynsford Estate
Camberwell, London SE5**

London Borough of Southwark

B7719
June 2015

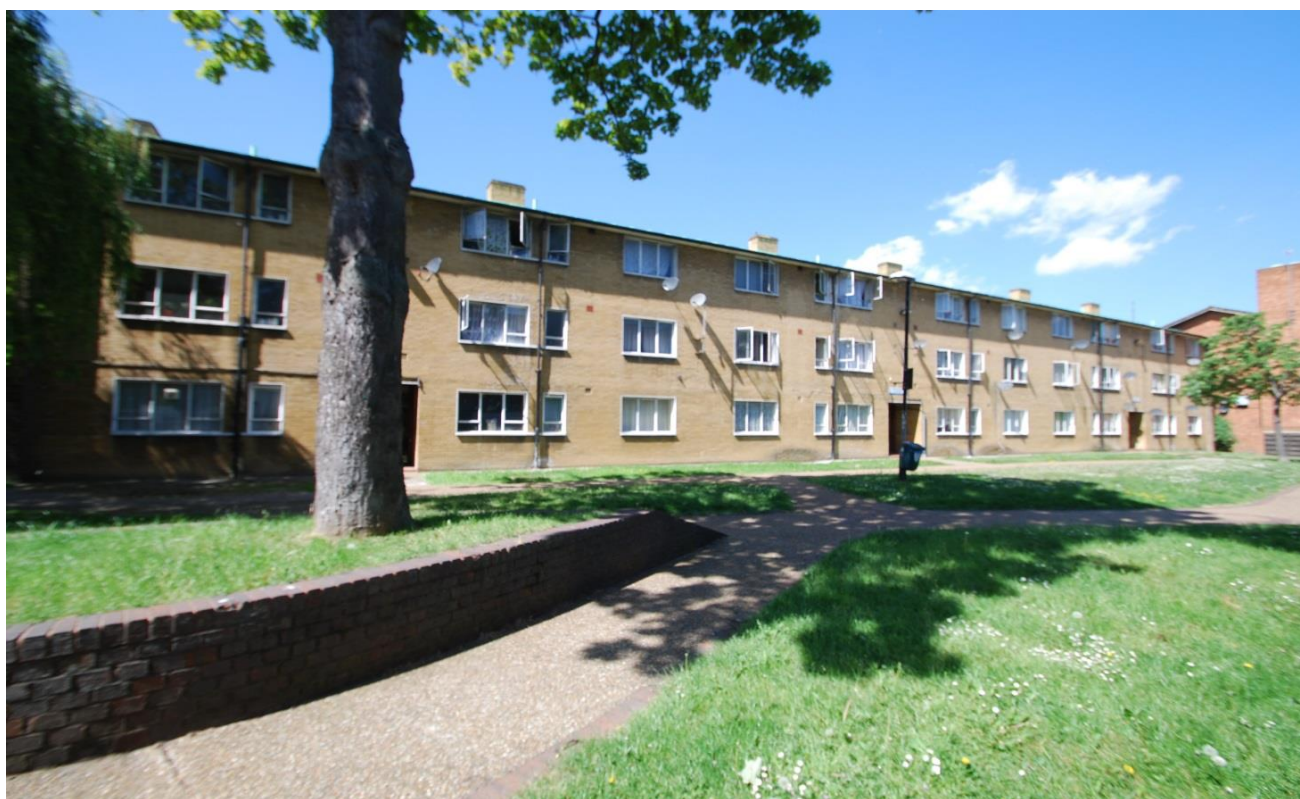
3.0 1-35 KIMPTON ROAD

1-35 Kimpton Road is a three-storey purpose built block of flats. The windows to both front and rear elevations are the original single glazed galvanised steel 'Crittall' type windows set into concrete reveals.

We recommend that consideration is given to replacing all the windows and private balcony doors with double glazed UPVc incorporating trickle vents in the head of all windows except to bathrooms and kitchens.

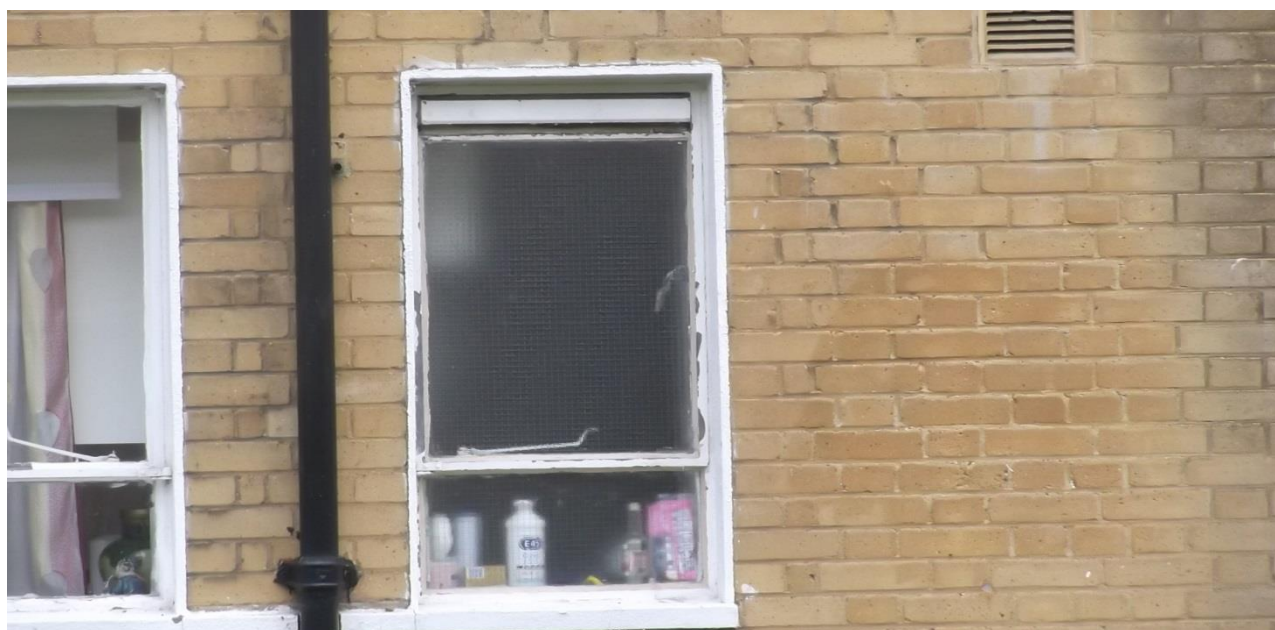
Some of the windows incorporate metal ventilators to the top of the windows.

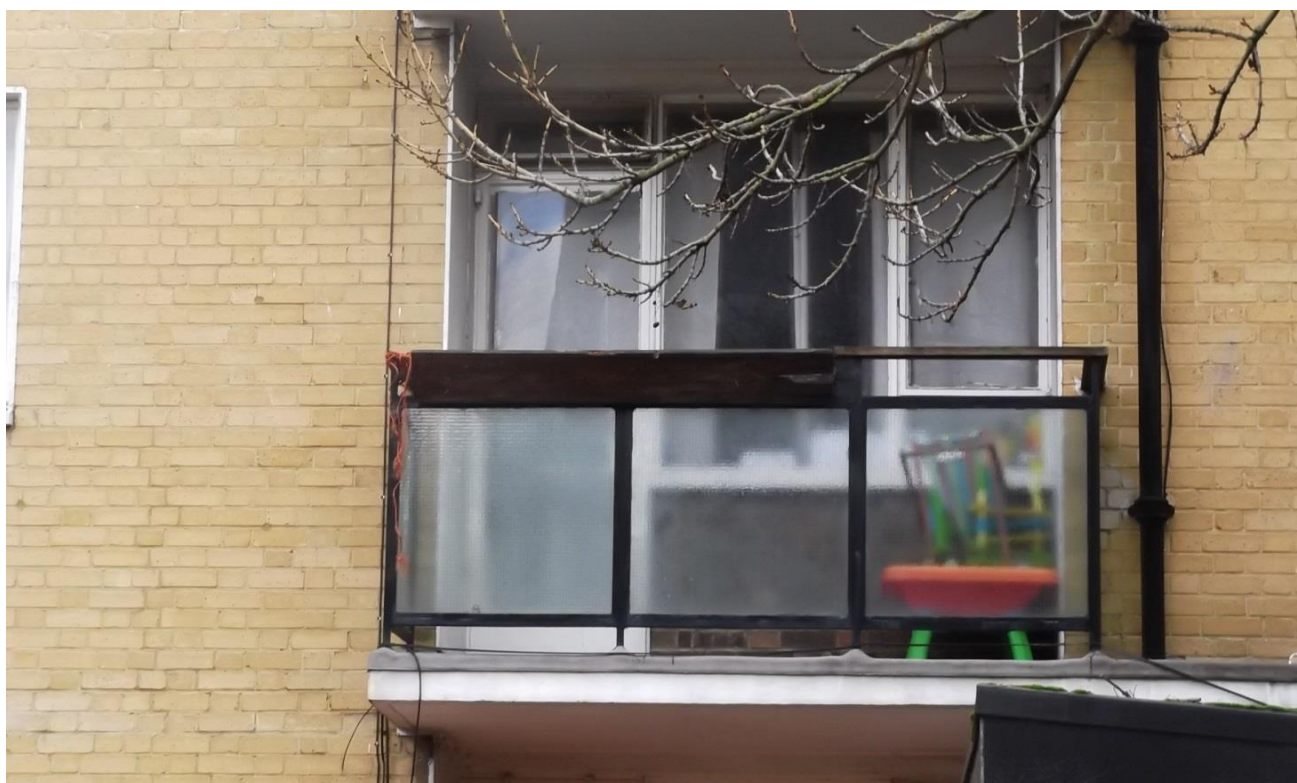
3.0 1-35 KIMPTON ROAD (cont'd)

To the rear, a door of the same material affords access to a private balcony.

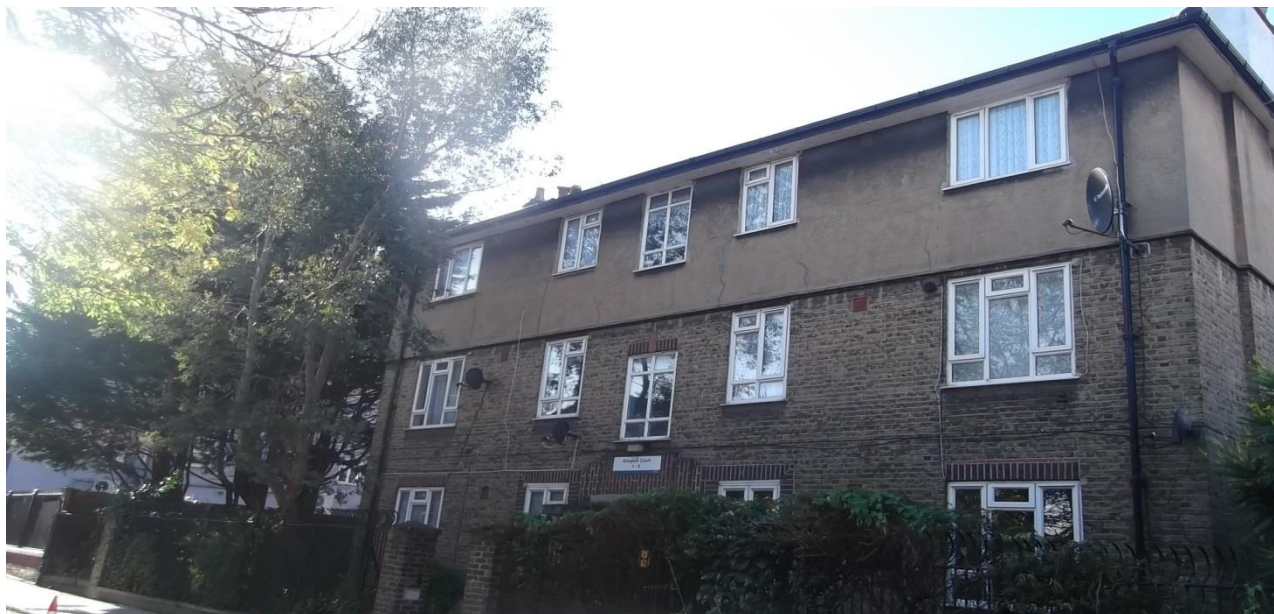
4.0 1-6 KIMPTON COURT

1-6 Kimpton Court is a three-storey detached block of flats. The windows to the front and rear elevations are double glazed UPVc which have been installed in recent years replacing the original, the construction of which is unknown.

These windows incorporate trickle vents in the head of the windows.

The windows are generally in good condition but we have been unable to ascertain when they were installed but from their condition, we would anticipate within the last ten years.

We recommend that the windows are retained but consideration could be given to changing the rear exit doors to the fire escape to a composite type with UPVC frame and double glazed fanlight over as the existing arrangement is unsightly and offers little security.
